REPORT OF PRE-RENOVATION ASBESTOS CONTAINING MATERIAL SURVEY, LEAD BASED PAINT SURVEY, AND HAZARDOUS BUILDING MATERIAL INVENTORY

Bell Auditorium Expansion and Renovations
Augusta, Richmond County, Georgia

NOVA Project Number: 3022112

July 1, 2022

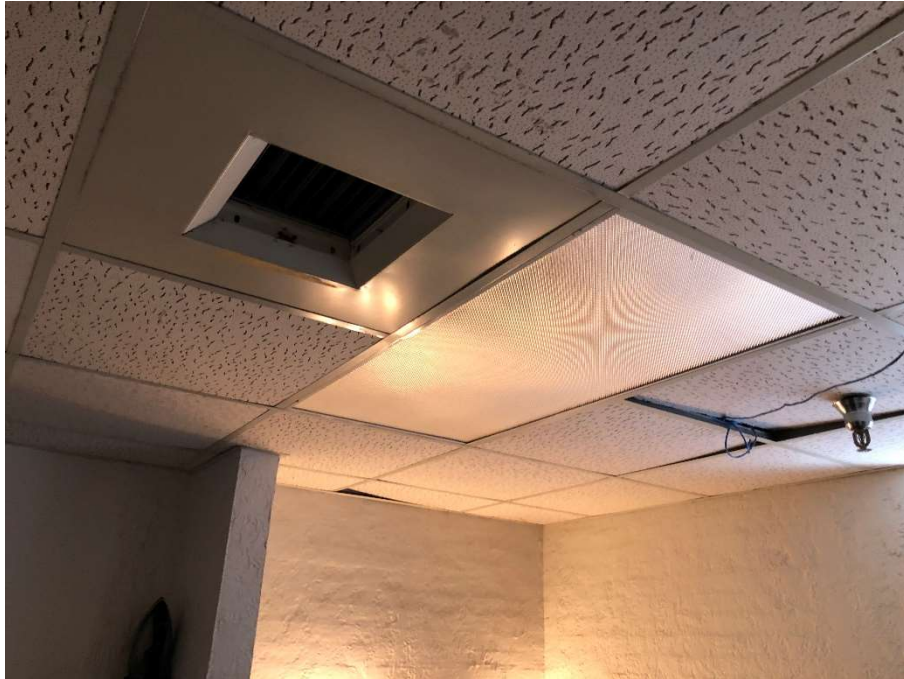
Photograph 1: Typical view of the 4' Fluorescent light ballasts located at the Subject Property.

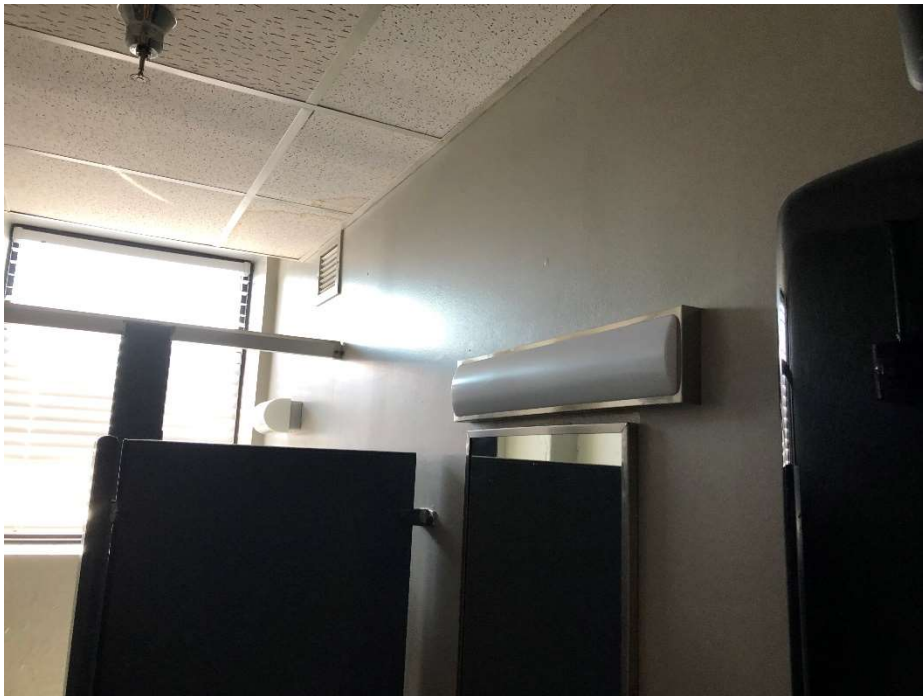
Photograph 2: Typical view of the 2' fluorescent light ballasts located at the Subject Property.

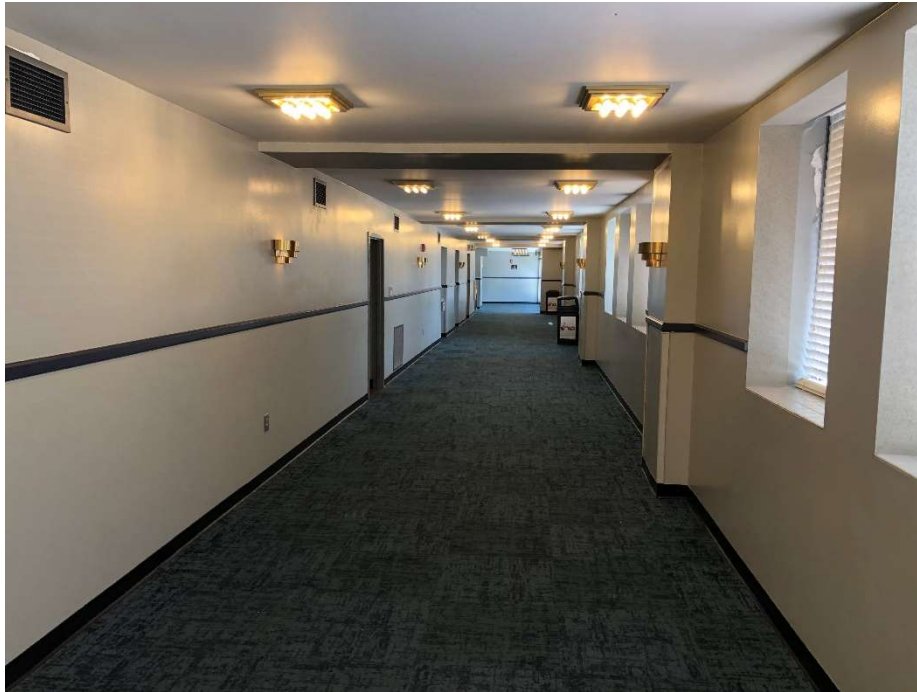
Photograph 3: Typical view of the single bulb fluorescent lighting located at the Subject Property.

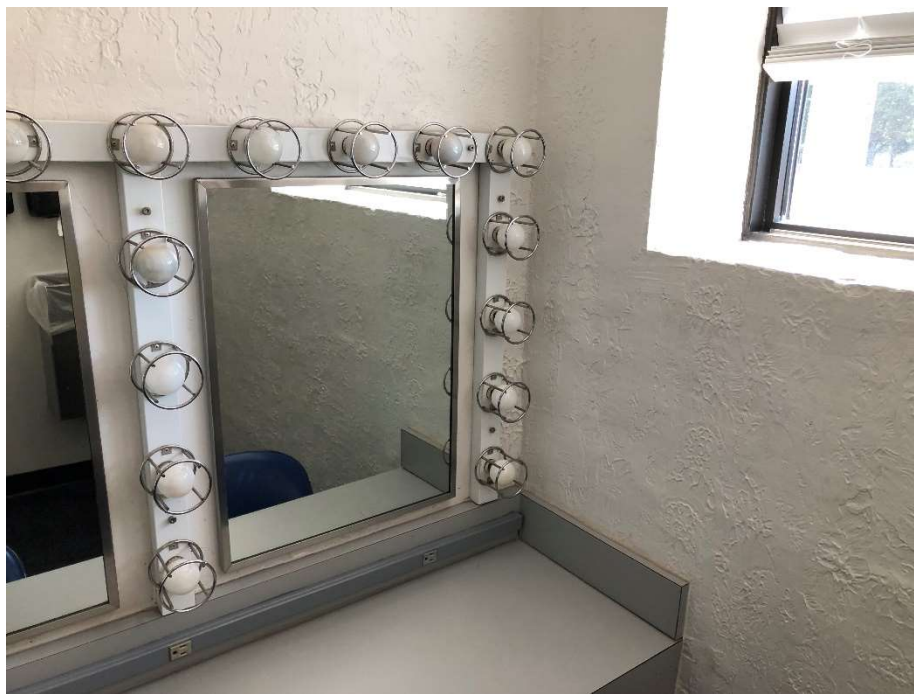
Photograph 4: Typical view of the incandescent lighting located at the Subject Property.

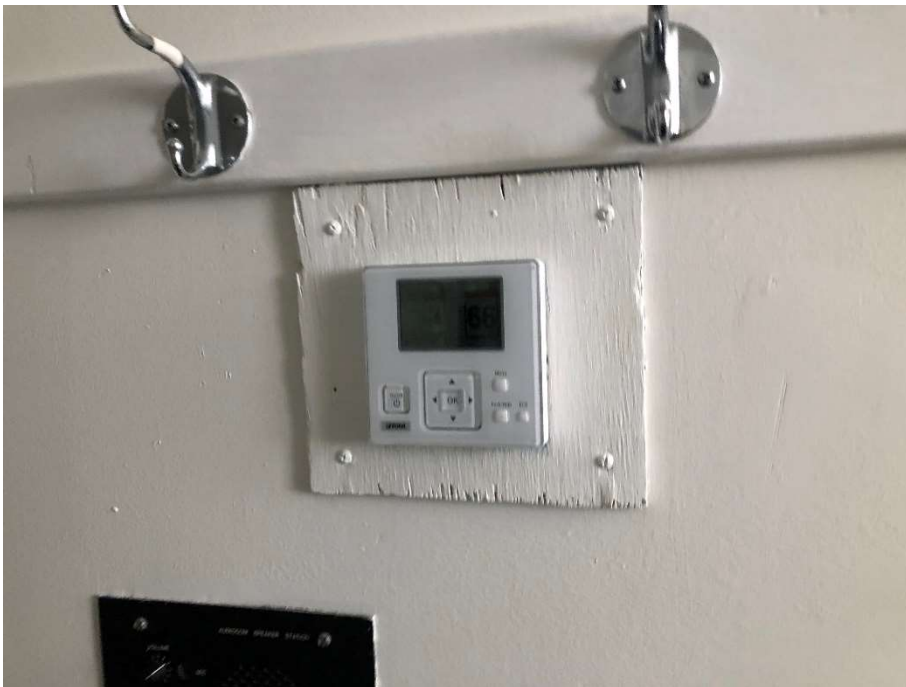
Photograph 6: Typical view of an electronic thermostat located at the Subject Property.

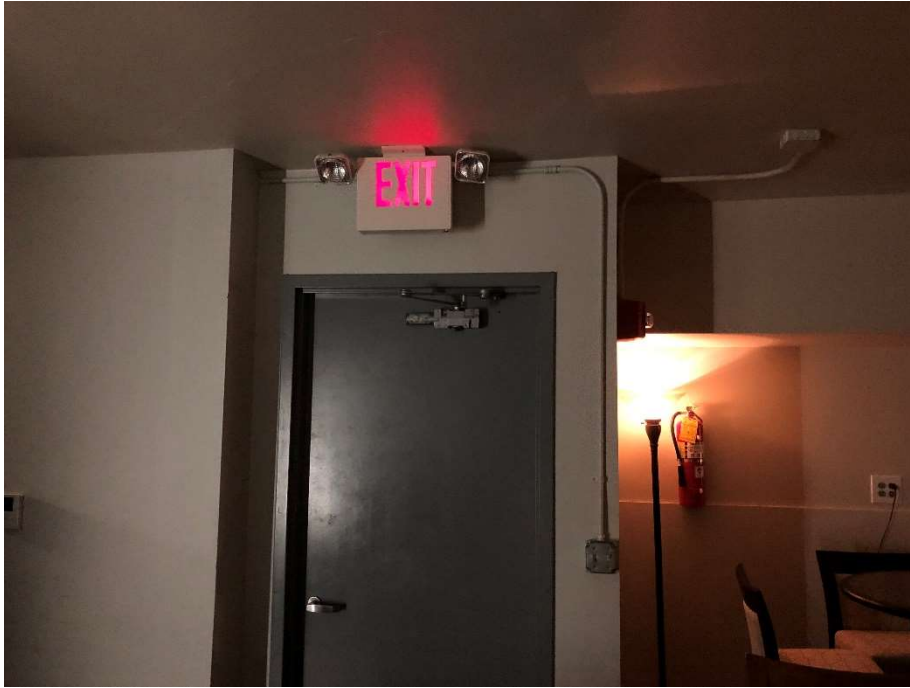
Photograph 7: Typical view of an exit sign located at the Subject Property.

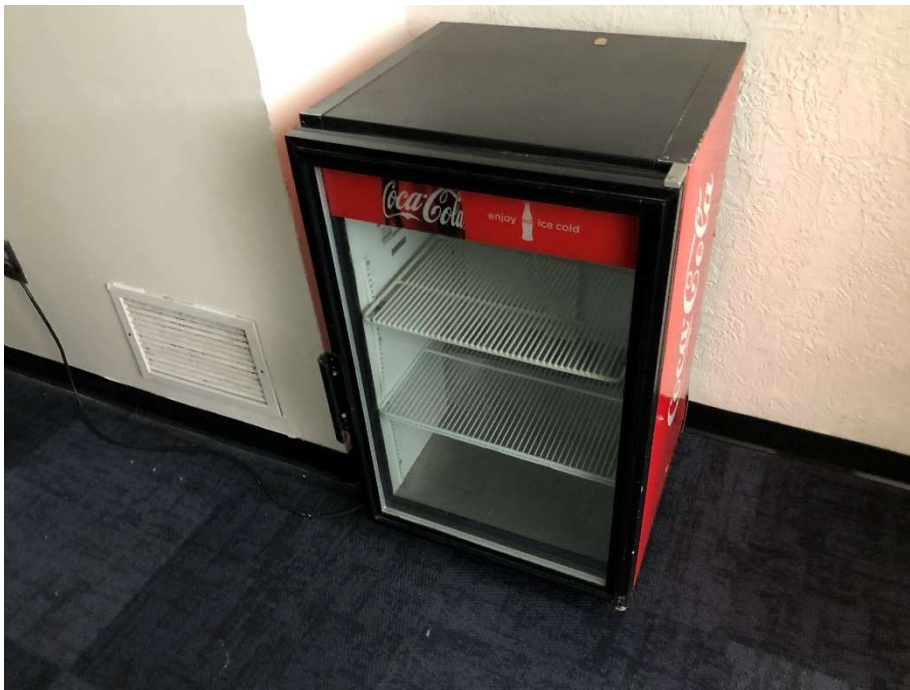
Photograph 8: Typical view of a refrigerator located at the Subject Property.

Air-Conditioning Units: Prior to disposal of units, refrigerant fluids should be removed from the equipment and transported for recycling or disposal in accordance with applicable regulations.

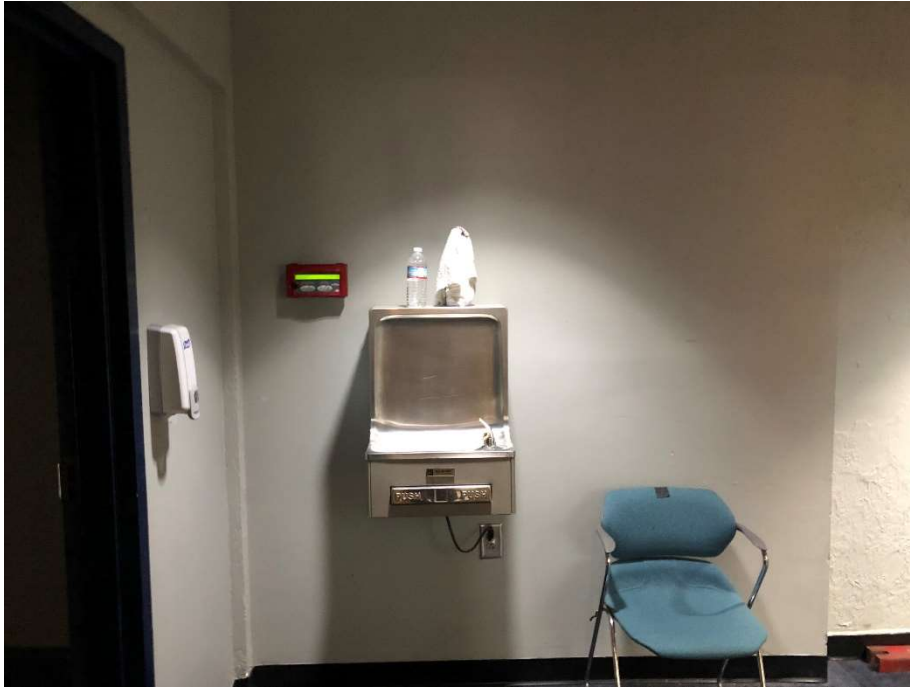
Photograph 9: Typical view of a water fountain bank located at the Subject Property.

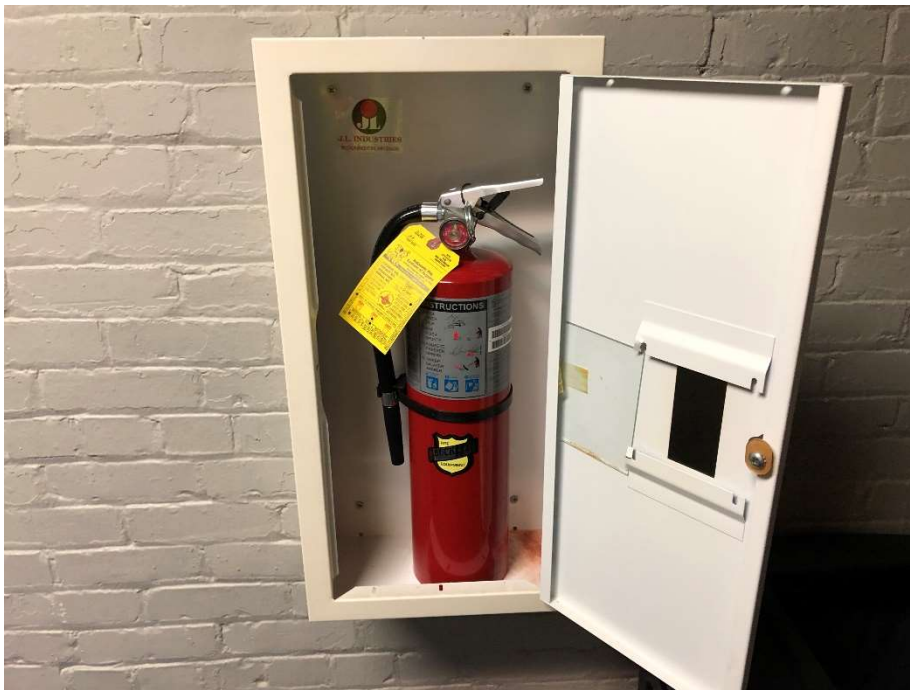
Photograph 10: Typical view of a fire extinguisher located at the Subject Property.
