LIMITED ASBESTOS INSPECTION REPORT

**James F. Byrnes High School- Phase III Demo. Project
150 E. Main Street
Duncan, SC 29334**

**INSPECTION DATE(S): November 6 & 7, 2023; January 3 & 15, 2024
REPORT DATE: January 26, 2024**

**Crossroads Environmental, LLC
1258 Boiling Springs Road
Spartanburg, South Carolina 29303
(864) 541-8736
CRE Project #23167-IN**

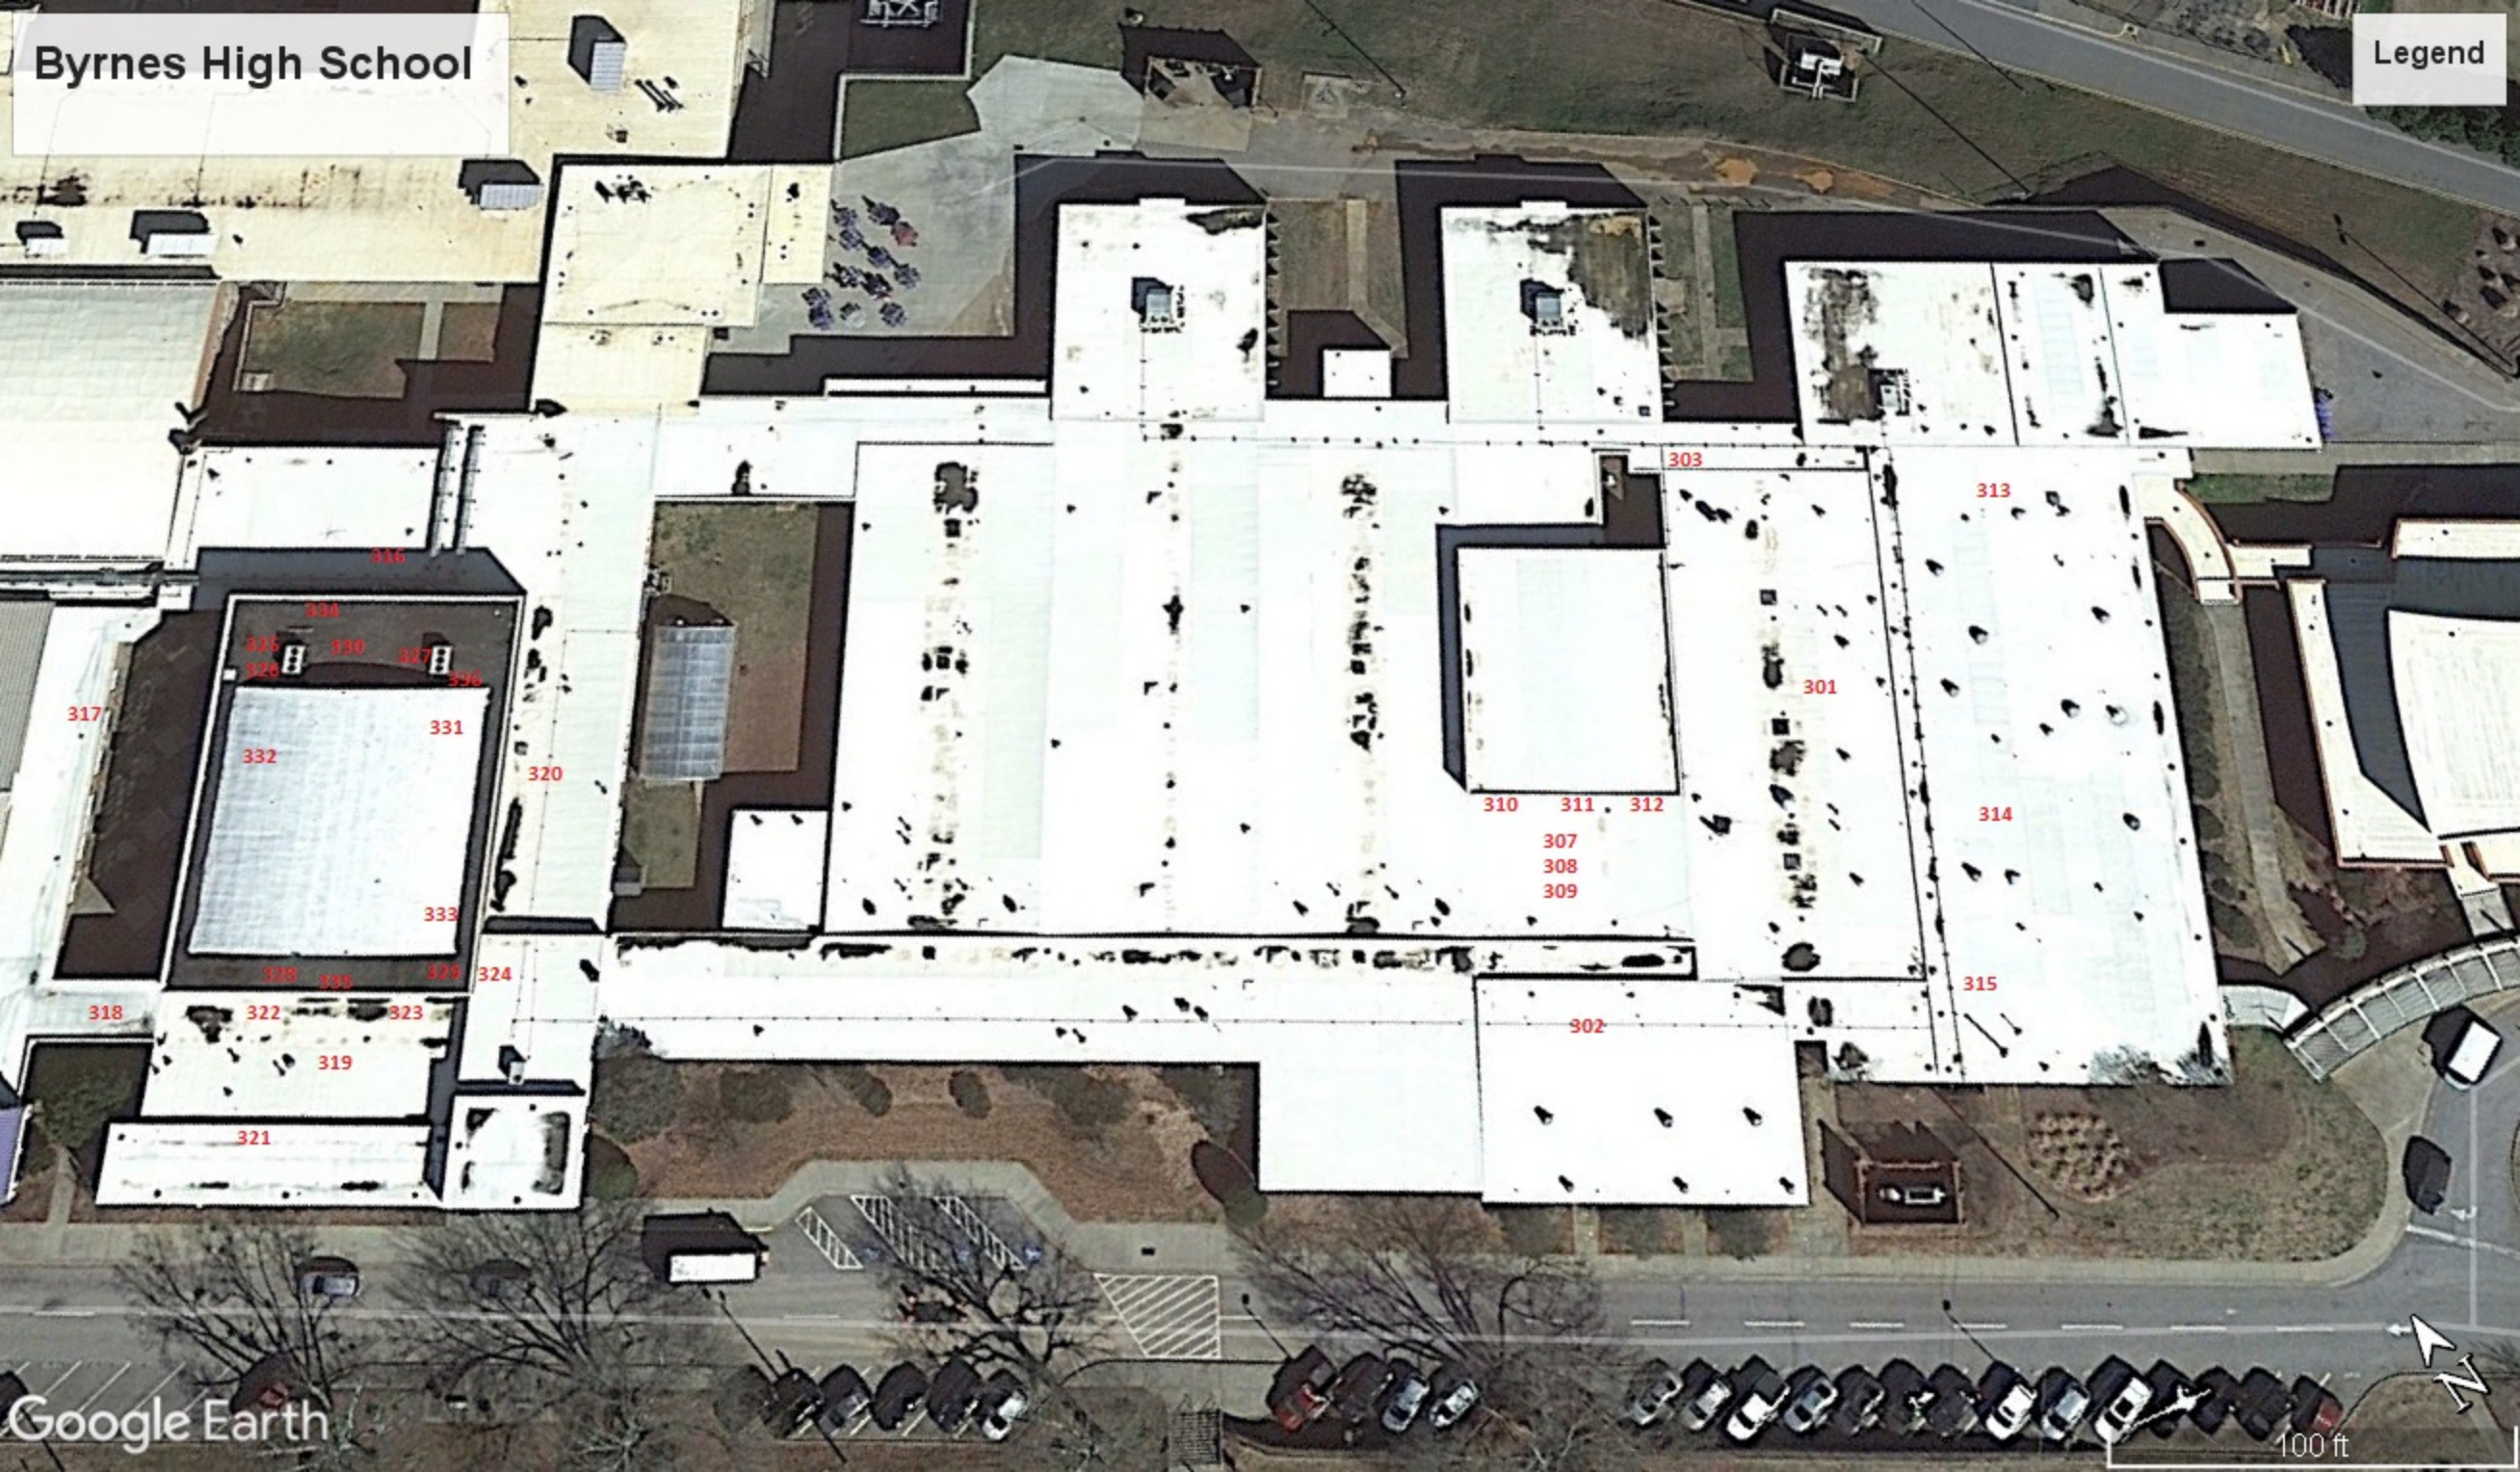
HA#'s

HA81: Built-up roofing of the flat roof section to the immediate south of the Media Center (see highlighted sketch).

HA86: Perimeter flashing brick flashing on the north, east and south sides of Auditorium (see highlighted sketch).

- 81
- 82
- 86
- 87
- 89
- 90
